**STILWELL LAKE DAM
ORANGE COUNTY, NEW YORK
INVENTORY NO. 770**

**PHASE I INSPECTION REPORT
NATIONAL DAM SAFETY PROGRAM**

NEW YORK DISTRICT CORPS OF ENGINEERS

DECEMBER 1978

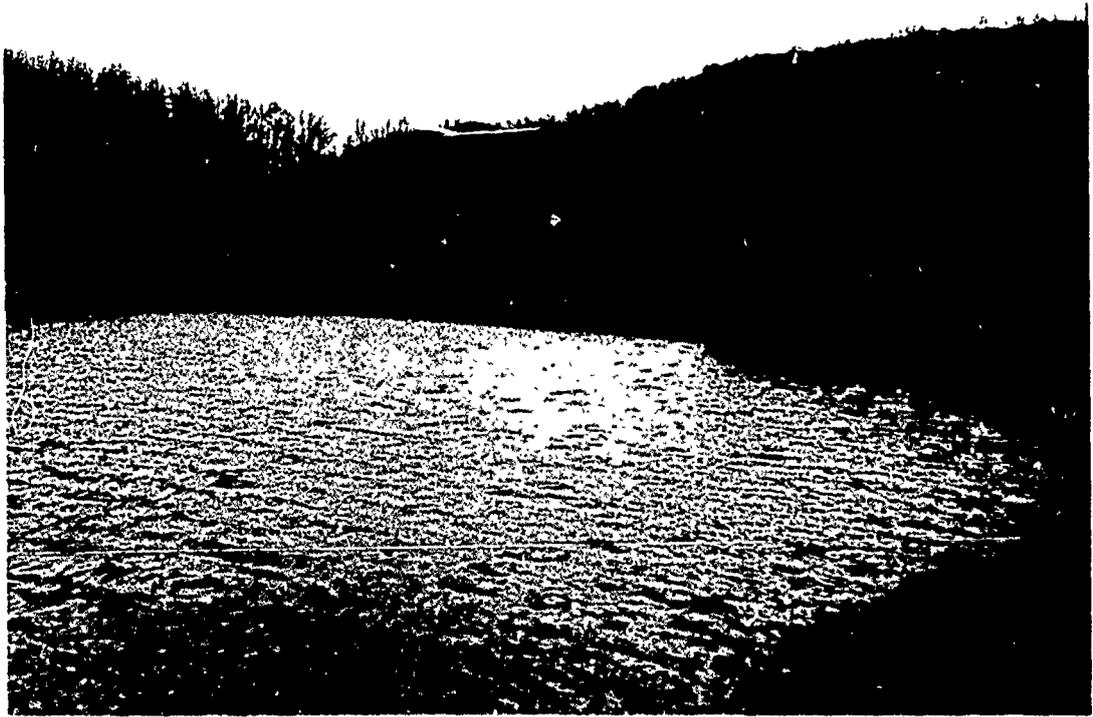
4. UPSTREAM VIEW OF DAM
